# **Shallow Water Shipwrecks Environmental Impact: MS VOLARE case study**

**Tarmo Kõuts, Kaimo Vahter and Siim Pärt**

Marine Systems Institute  
Tallinn University of Technology

**WRECKS OF THE WORLD III**  
**October 12-13 2015, Gothenburg, Sweden**

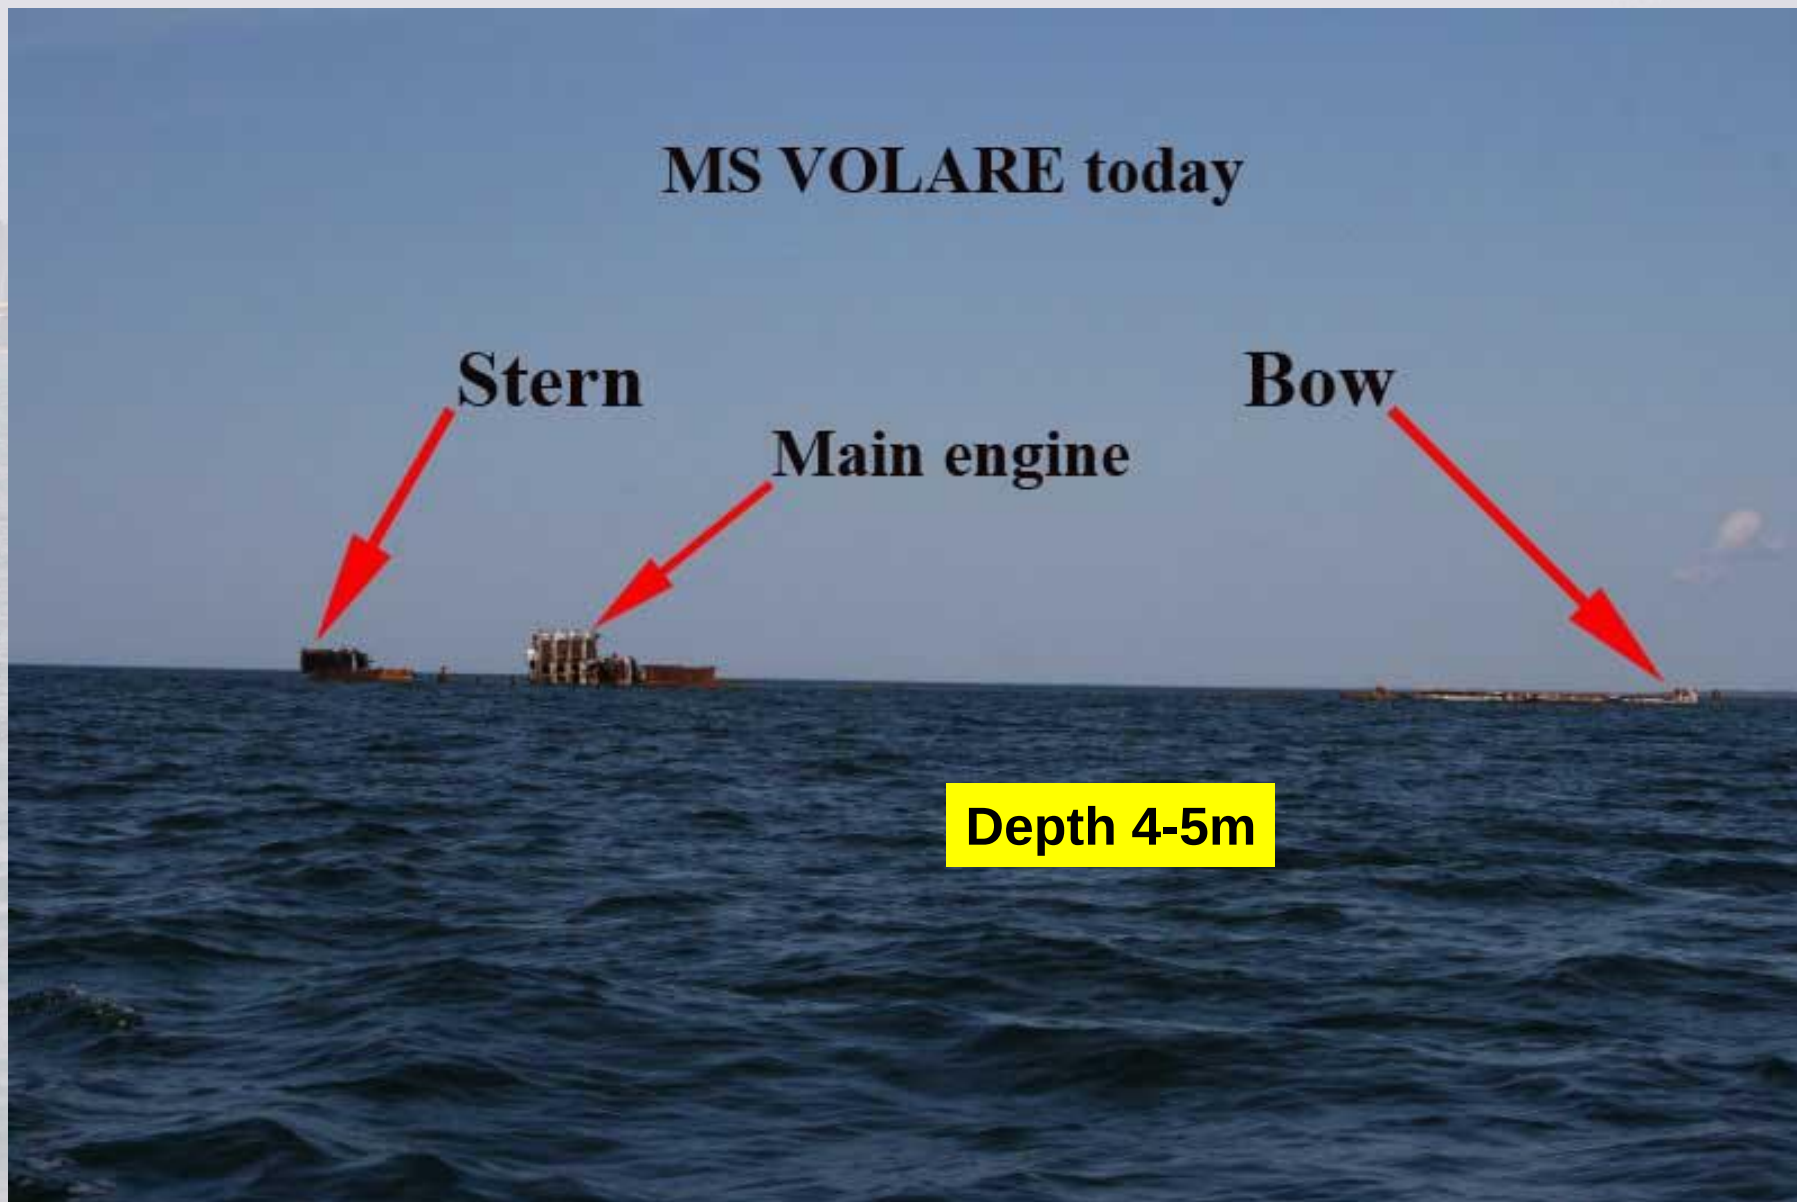
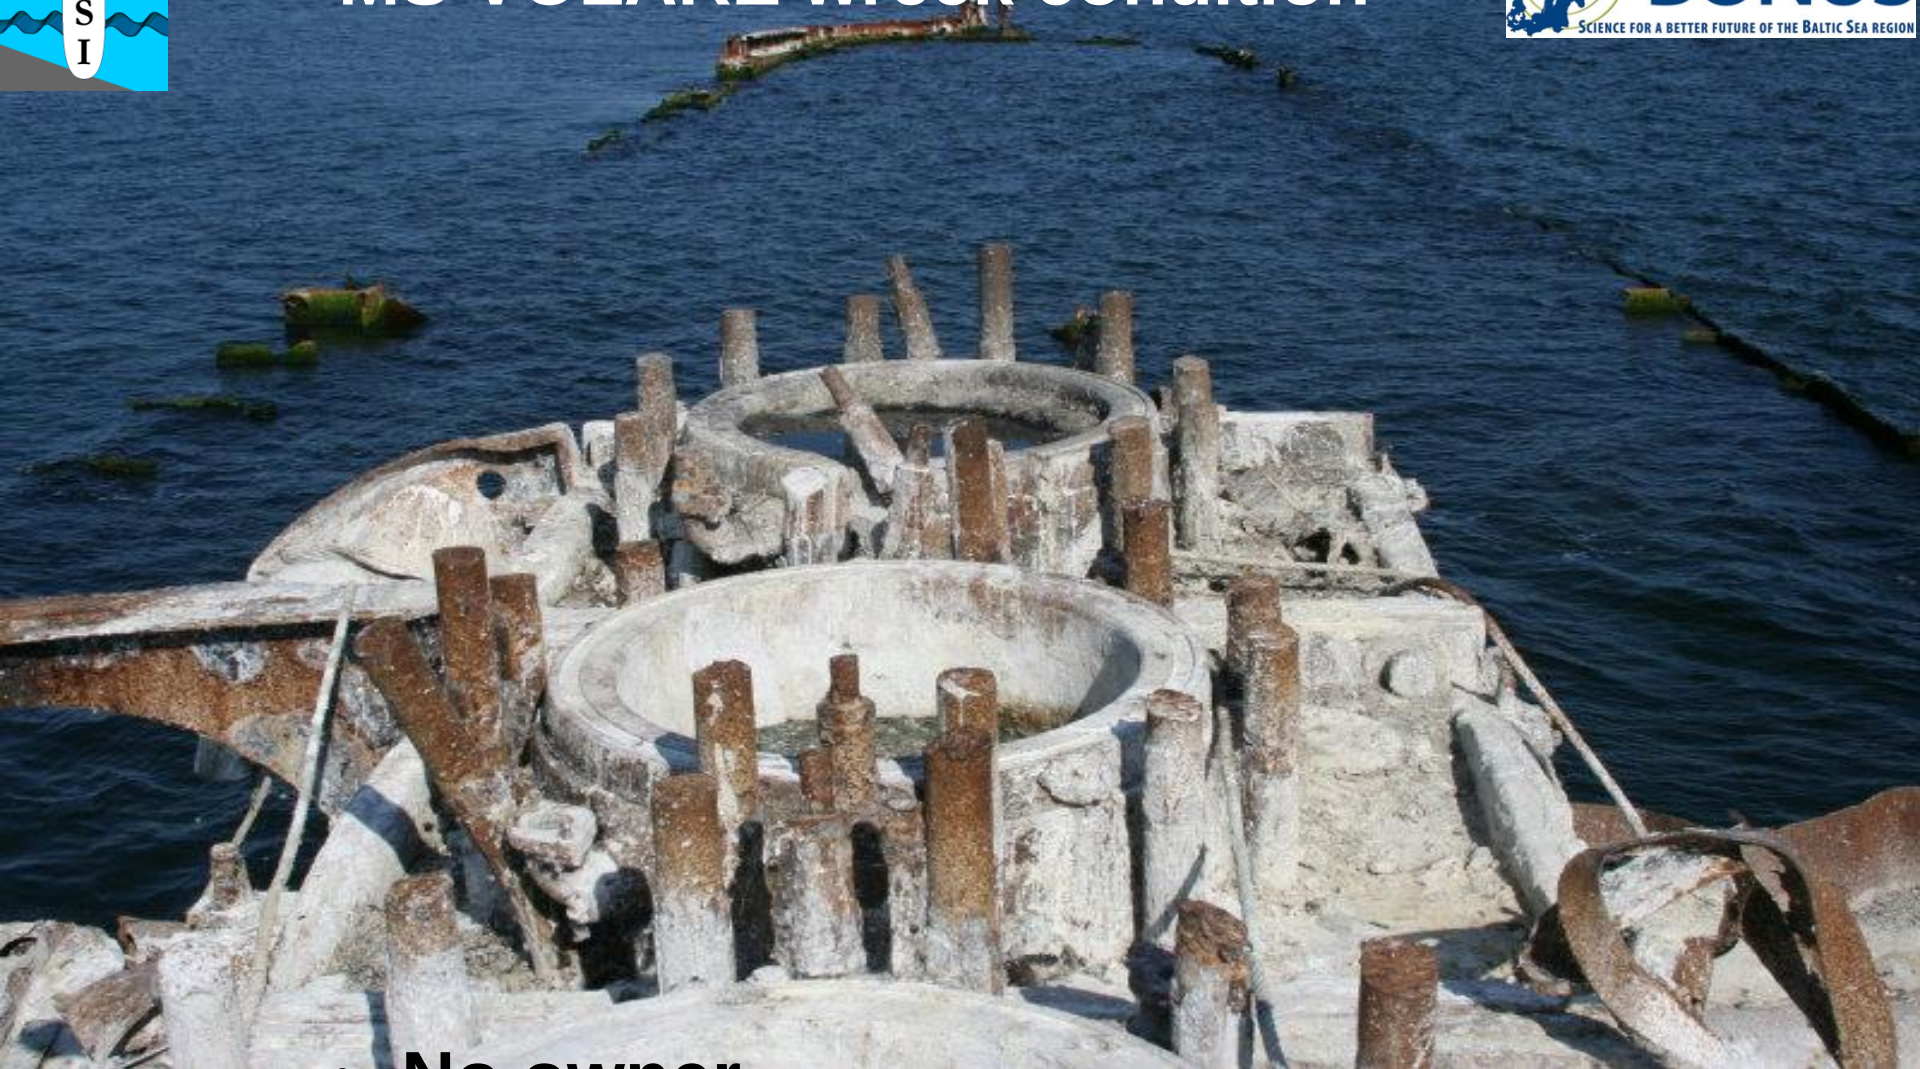
# MS VOLARE wreck

**MS VOLARE today**

**Stern**

**Main engine**

**Bow**

**Depth 4-5m**

- No owner
- Burned many times
- Wild metal scrappers

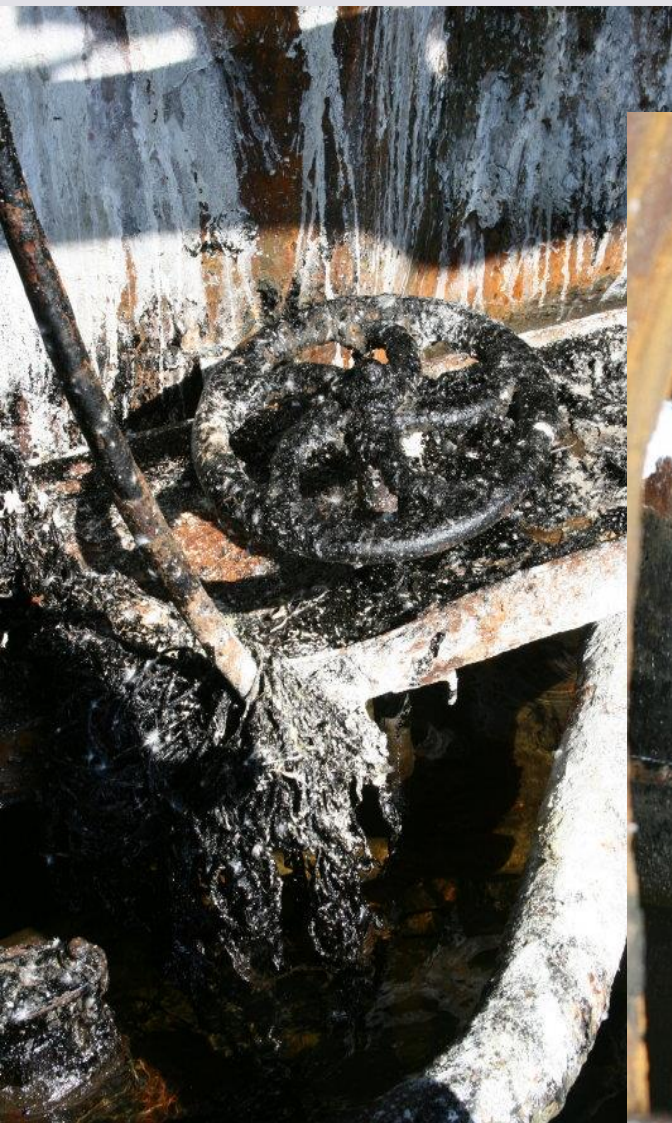
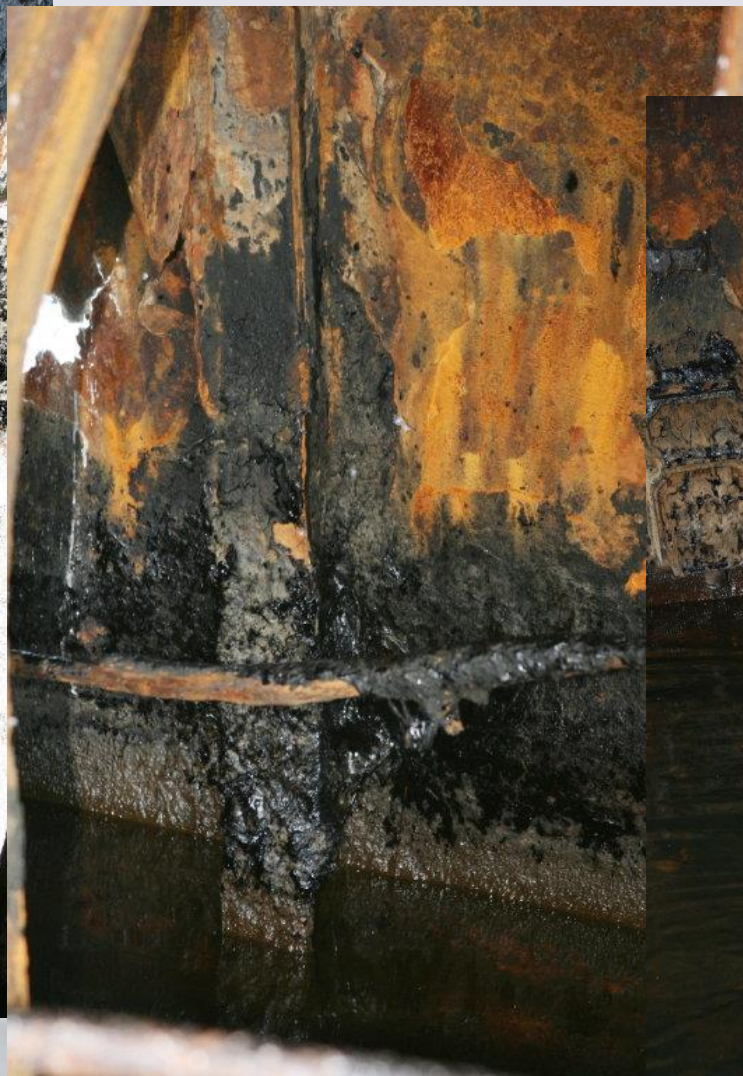
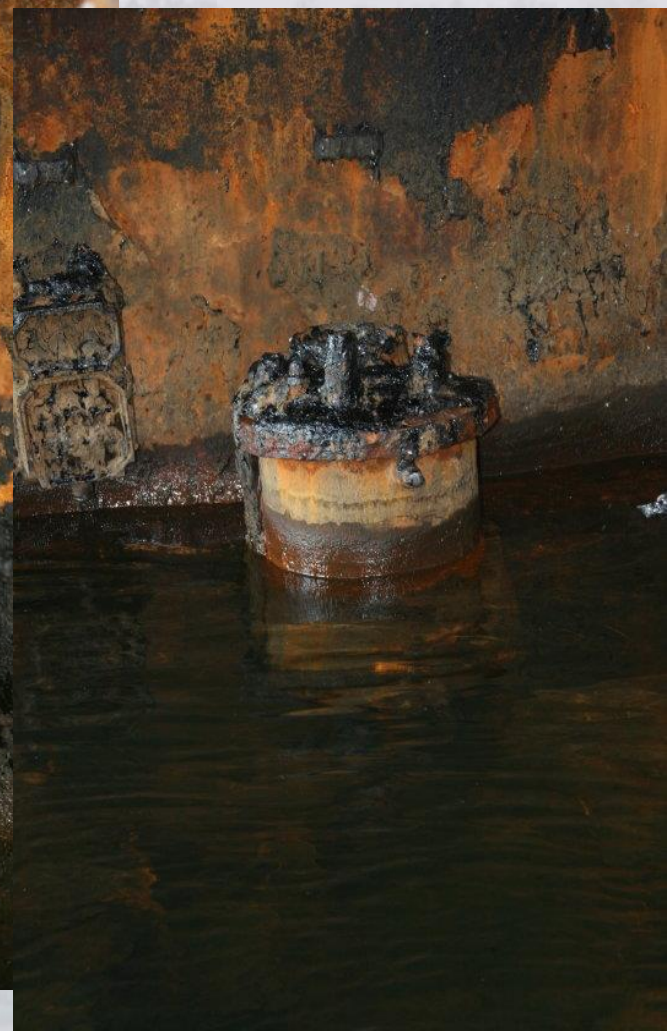
# Unknown amount of oil onboard

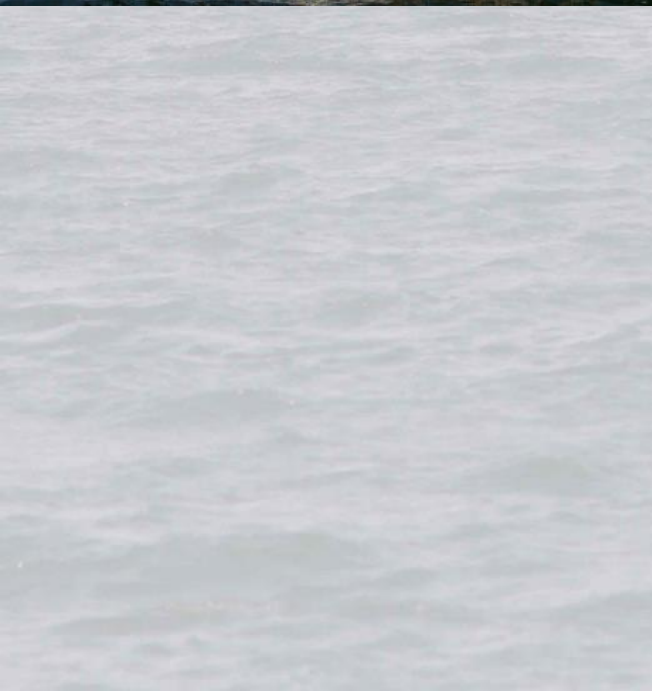
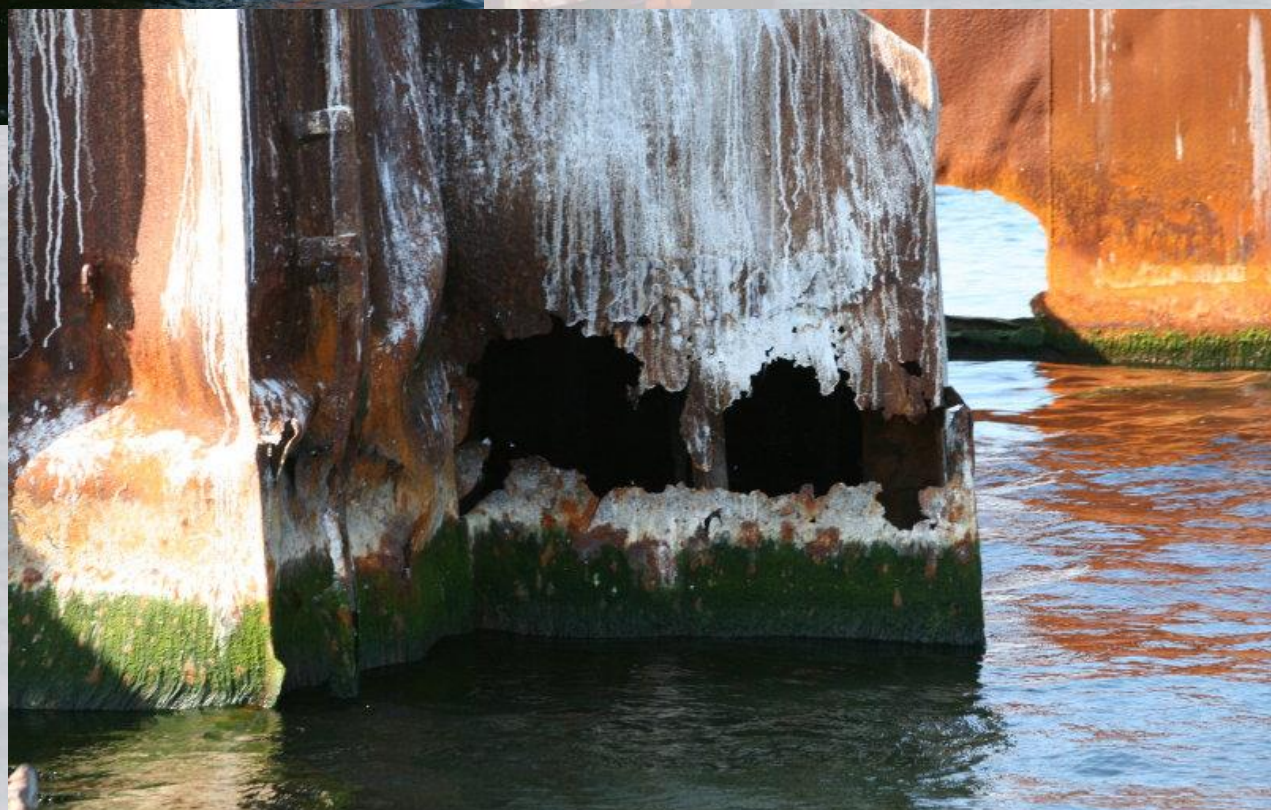
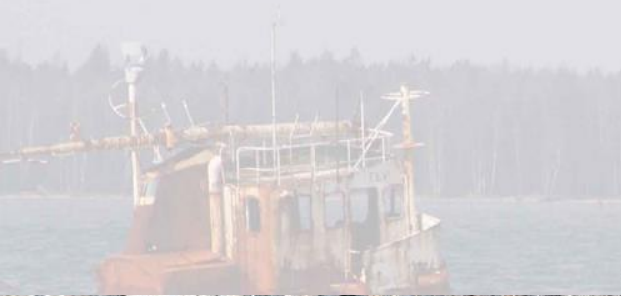
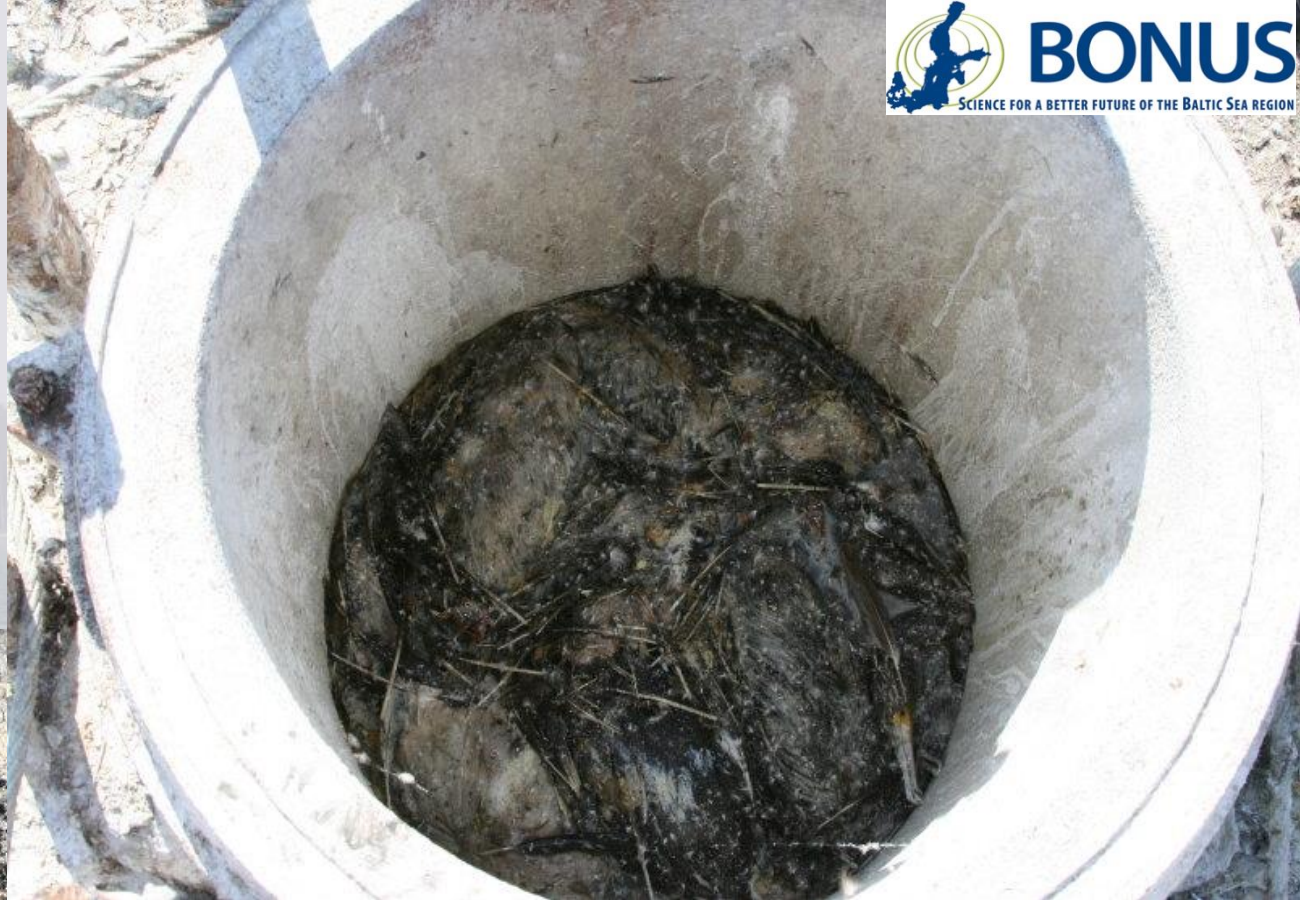
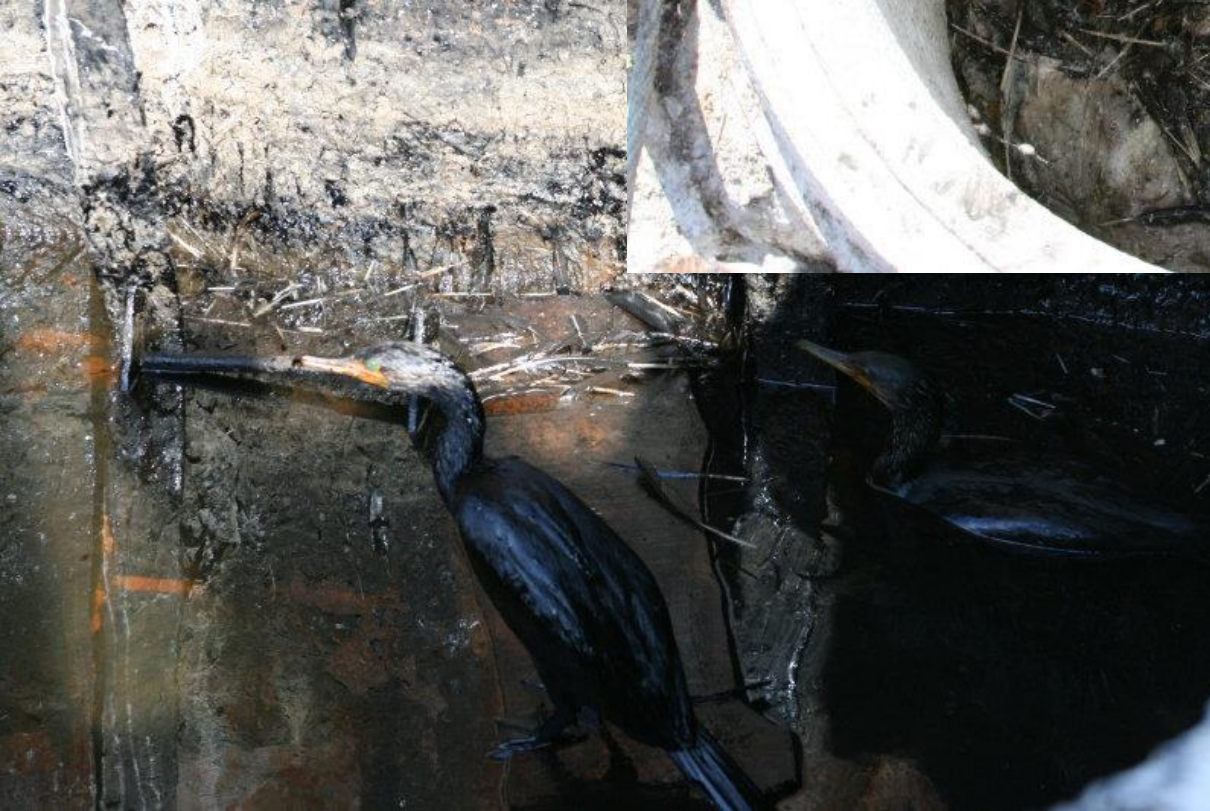
# Wreck's condition deteriorates

**Trap  
for birds  
(cormorant),  
fishes,  
marine mammals?**
