CRUISE REPORT

R/V Aranda

Cruise 08/2022

HYLYT 1 2022
28.8.2022 – 2.9.2022

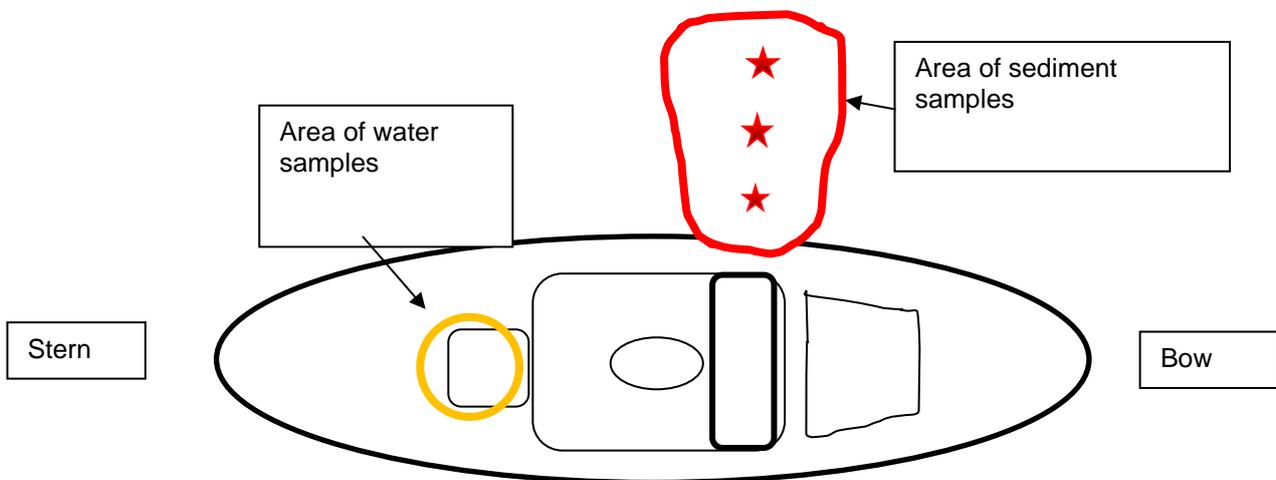
Fig 2. Water- and sediment sample locations in relation to wreck

On Thursday 1st Sept we started the work by taking water samples directly above the engine room skylight at various depths from practically deck level to surface. After that a series of sediment samples from port side of the wreck, in order to find out if any oil had slipped into sediment layers (Fig 2.). After this we continued with further ROV work. Before leaving the site, we also tested Aranda's SSS which operated flawlessly.
